Shining Examples of Cost-Effective Energy and Carbon Emissions Optimization in Building Renovation (Annex 56)

Energy in Buildings and Communities Programme

May 2014

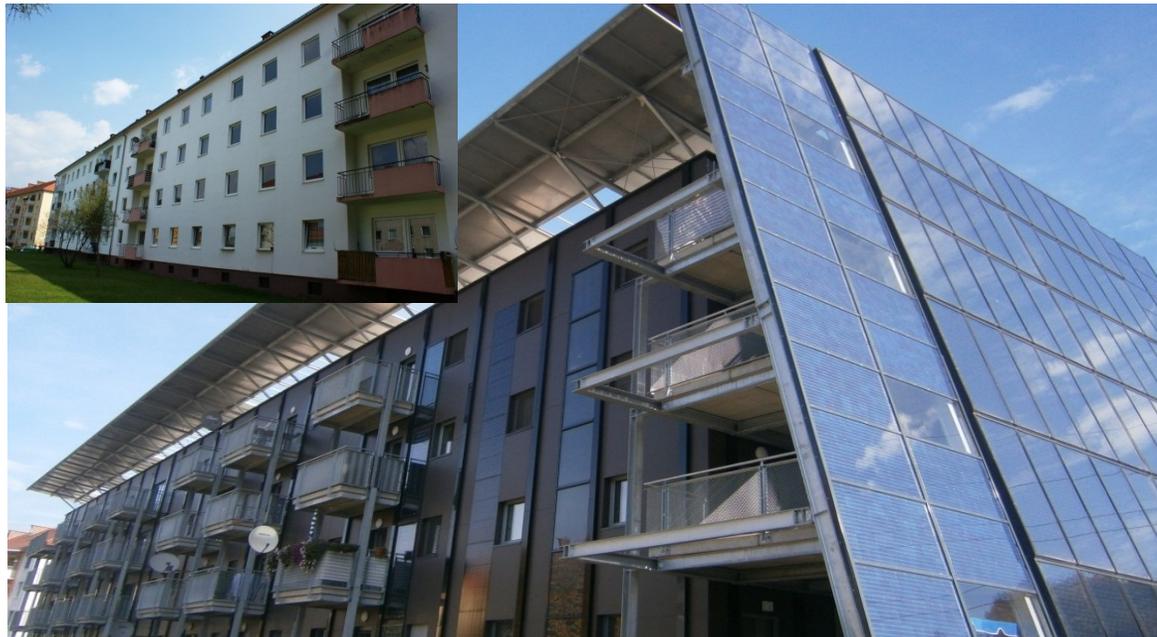
View of existing (small picture) and the renovated building (large picture) (west elevation)

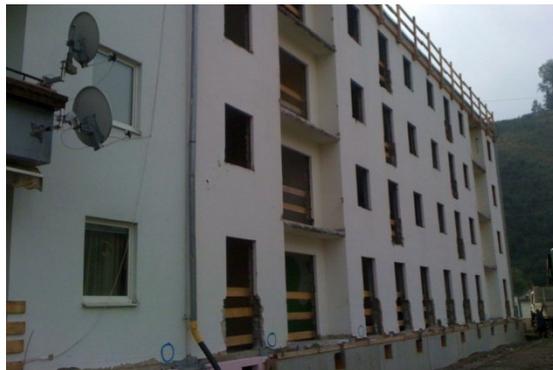
Façade during the renovation

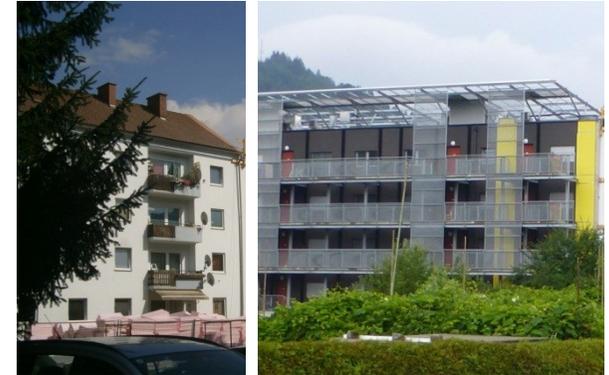
Facade – before and after the renovation

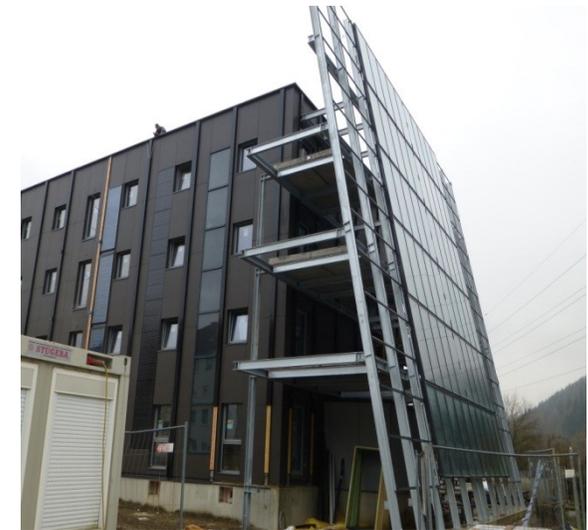
Solar thermal and PV panels on the south facade

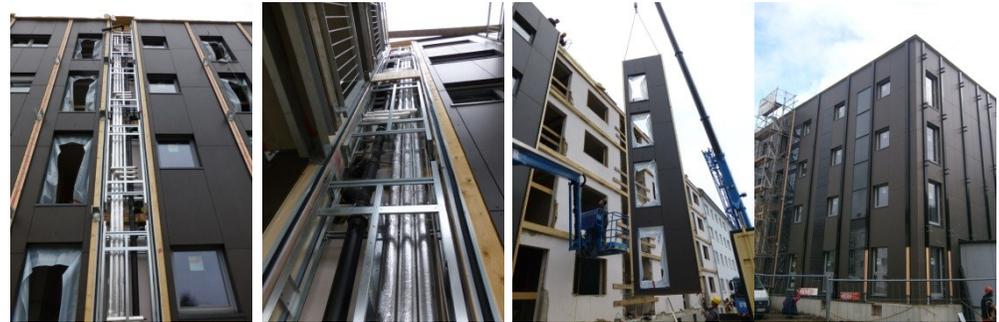
Different steps of the building renovation process: installation of the building services, assembling of the prefabricated façade modules, almost finished building envelope (f.l.t.r.)

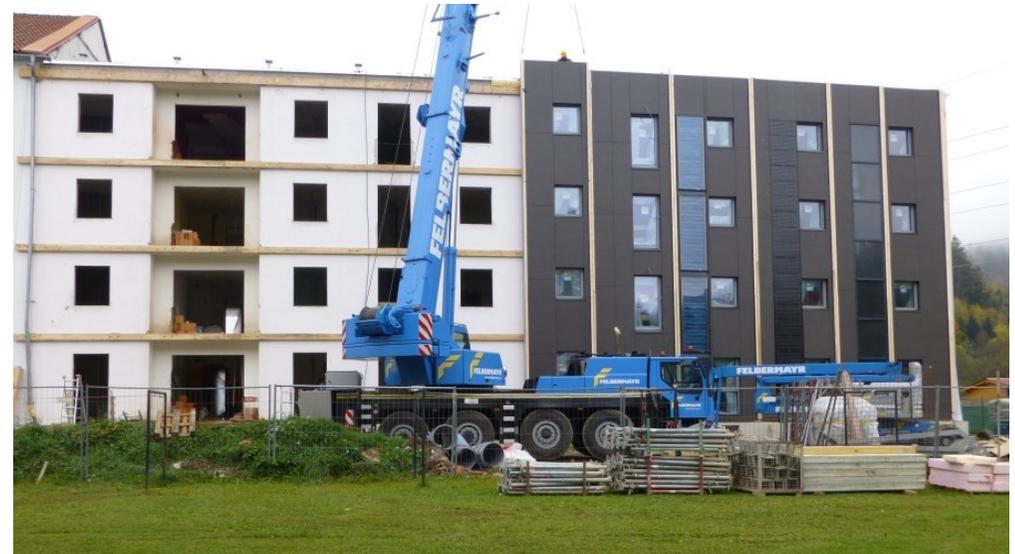
Assembling of the prefabricated façade modules on the west facade

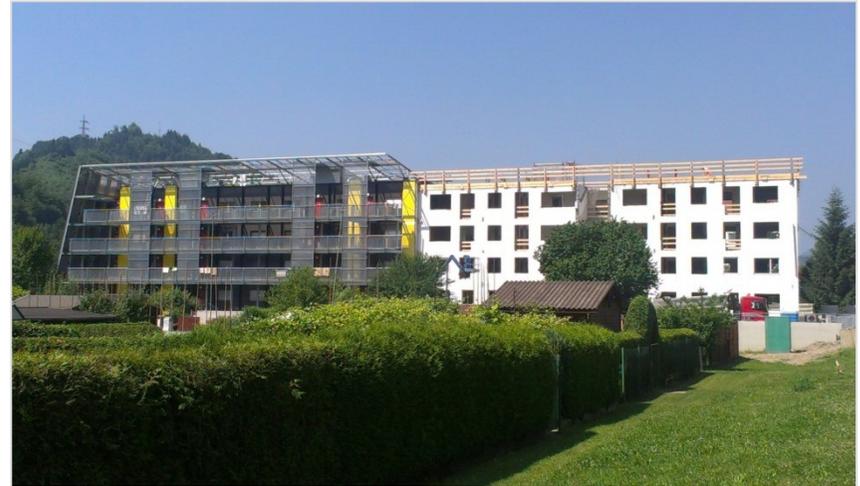
Left building part: finished renovation; right building part: still in renovation

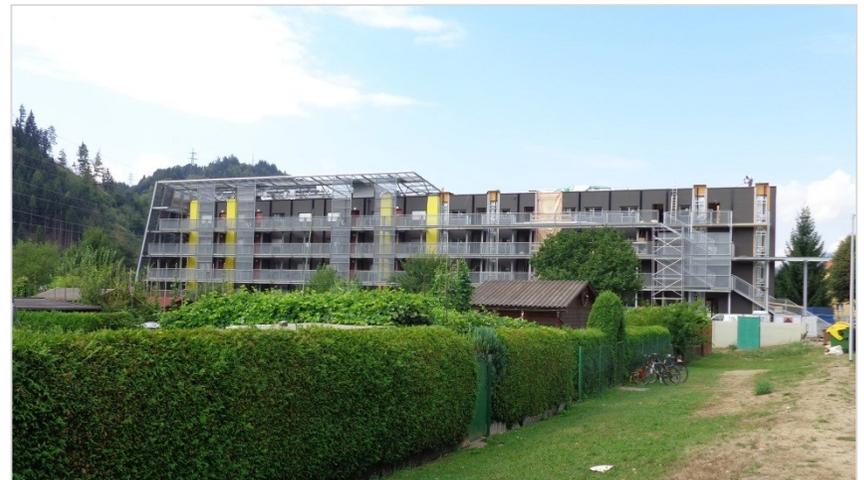
A few days later – building envelope of the right building part almost finished

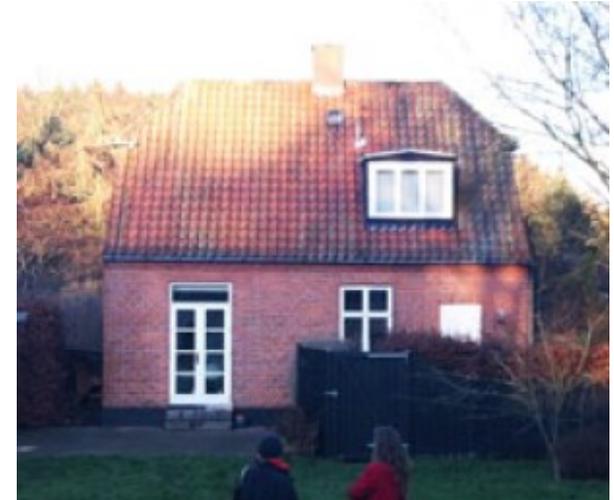
Above: Seen from the garden before renovation

Below: The new vapour barrier on the loft

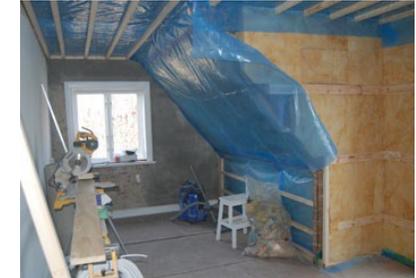
Insulation of mansard walls and lost space walls in attic incl. vapour barrier and internal insulation of the pediment

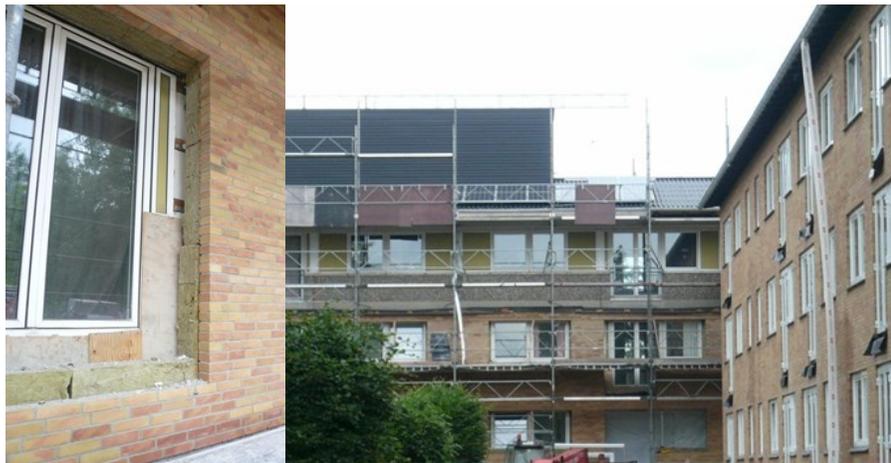
Figure: 190 mm insulation plus exterior solid standard bricks. Energy windows – aluminium – wood, 3-layer energy glass. In the panel walls: 285 mm insulation plus exterior solid standard bricks.

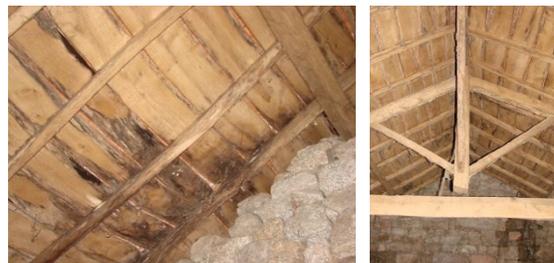
Roof condition and characteristics

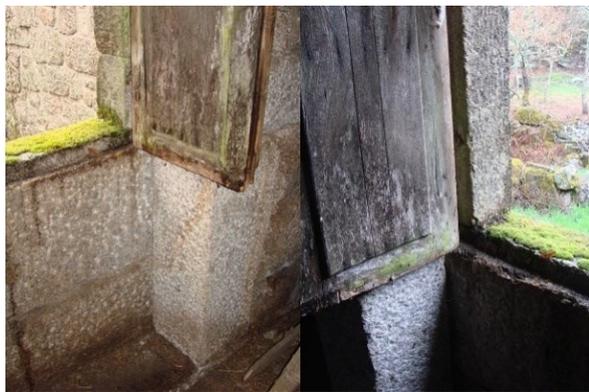
Existing window sills

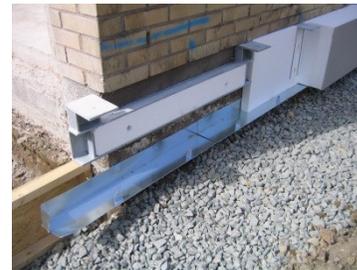
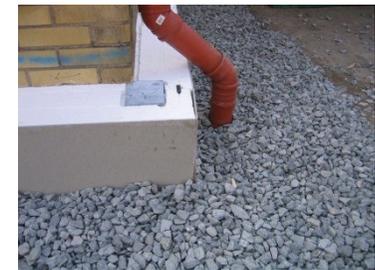
Added insulation to the foundation

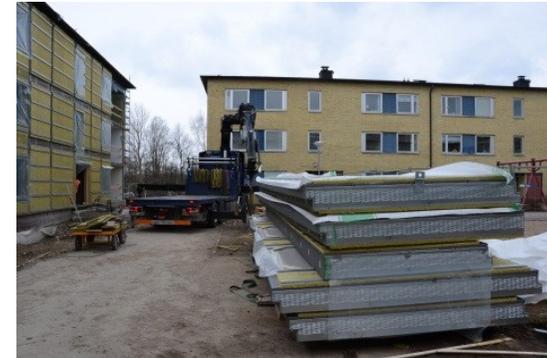
Prefabricated facade elements for the next phase of renovation.

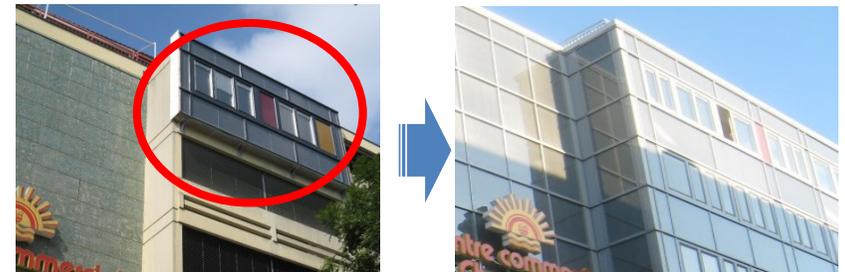
Pre-fabricated solar facade system from gap-solution

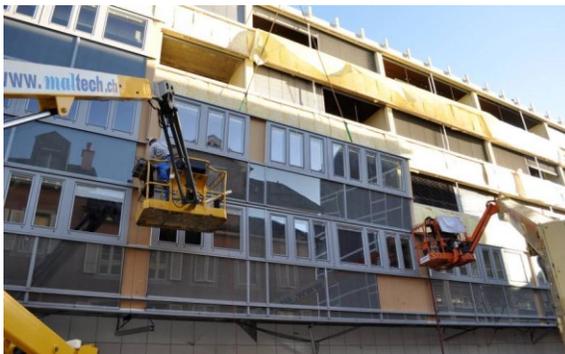
New prefabricated modules during the renovation
